930,599 Mile Engine 1 Million Mile Van

Delivery Driver Tests AMSOIL

CHRONOLOGY OF ANALYSIS

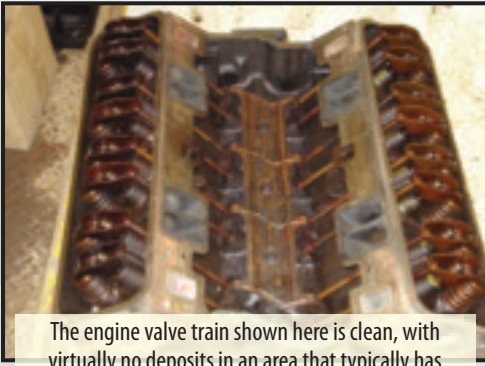
The engine valve train shown here is clean, with virtually no deposits in an area that typically has sludge and heavy carbon buildup with conventional motor oil.

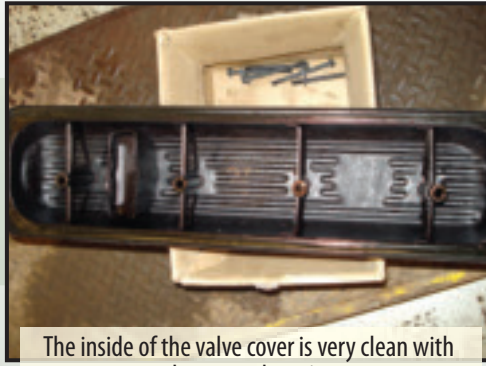
The inside of the valve cover is very clean with almost no deposits.

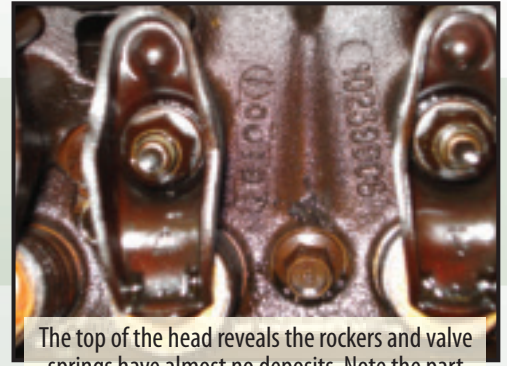
The top of the head reveals the rockers and valve springs have almost no deposits. Note the part numbers still are visible.

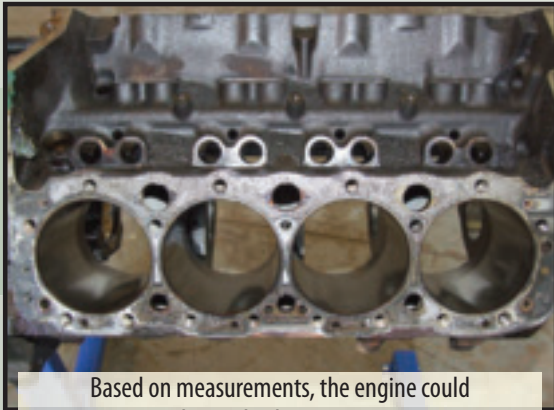
Based on measurements, the engine could be put back in service.

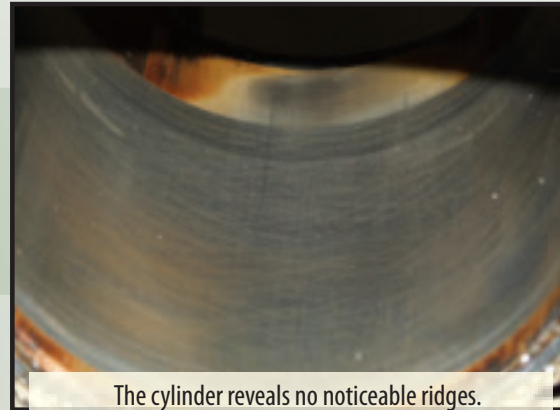
The cylinder reveals no noticeable ridges. Note crosshatch marks still are present.

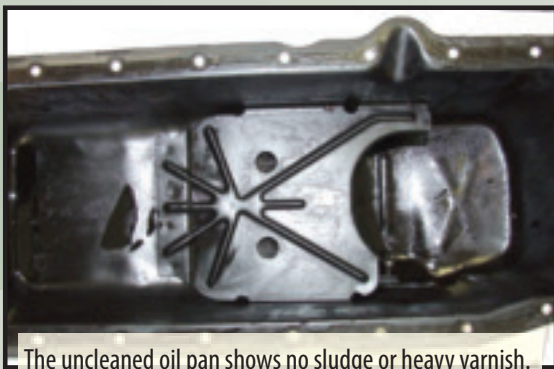
The uncleaned oil pan shows no sludge or heavy varnish.

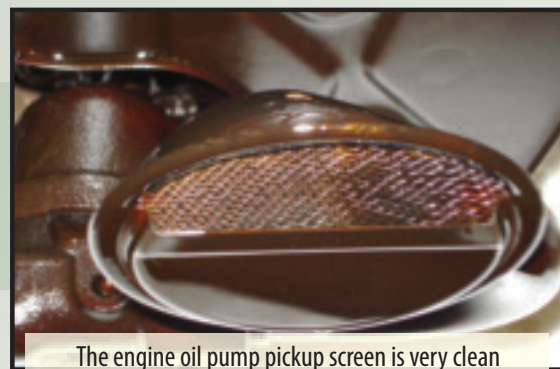
The engine oil pump pickup screen is very clean and has no deposits.

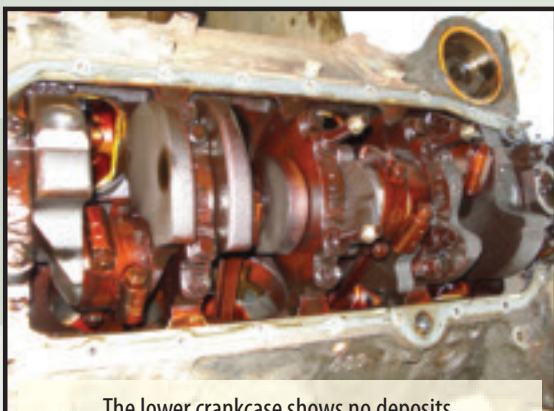
The lower crankcase shows no deposits.

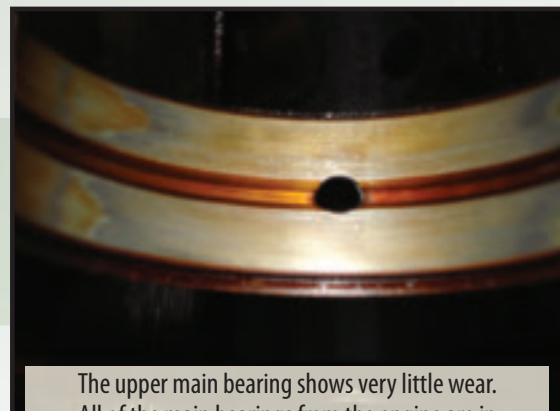
The upper main bearing shows very little wear. All of the main bearings from the engine are in useable condition, according to the analysis.
