Engine Overhaul Creates Lots of Build Debris

Spinner II® CS System Effectively Traps It

Spinner II® Profit Builder No. 102
Helpful Sales Tools for Representatives of Spinner II Products

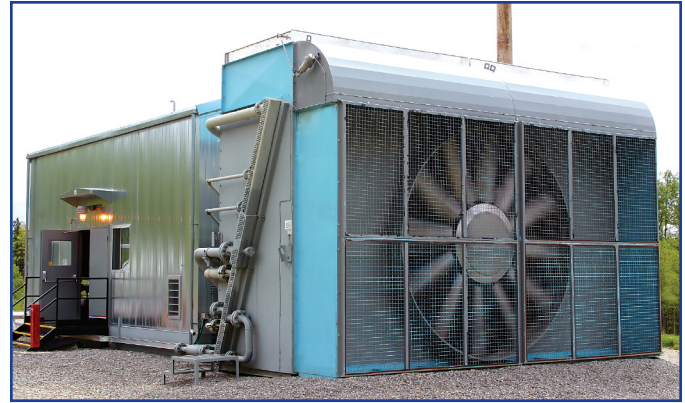
The factory-fit lube filtration system was replaced with a Spinner II CS centrifuge/cleanable screen system before the engine was returned to service.

After only 120 operating hours, the screen pressure drop had increased to 35 psid, a level well-beyond the normal service point. After the screen was removed from the housing, the operator found it was covered with small slivers of steel and bronze which had been “chewed up” during engine break-in. A quick clean-up of the screen with water jet spray removed the trapped debris.

The centrifuge/screen system has now achieved 70 days of continuous operation. Since the centrifuge continues to trap wear debris (approximately 500 grams in the bowl at last check), the screen is still operating below change-out pressure levels. The operator has concluded that by applying a filtration design that allows *no filter bypass* during the high dirt loads at start-up, catastrophic failures after overhaul are prevented.
